Walker Fraser Steele
Chartered Surveyors

DUNEDIN ESTHER PLACE

Energy Performance Certificate

DUNEDIN, ESTHER PLACE, TAIN, IV19 1HN

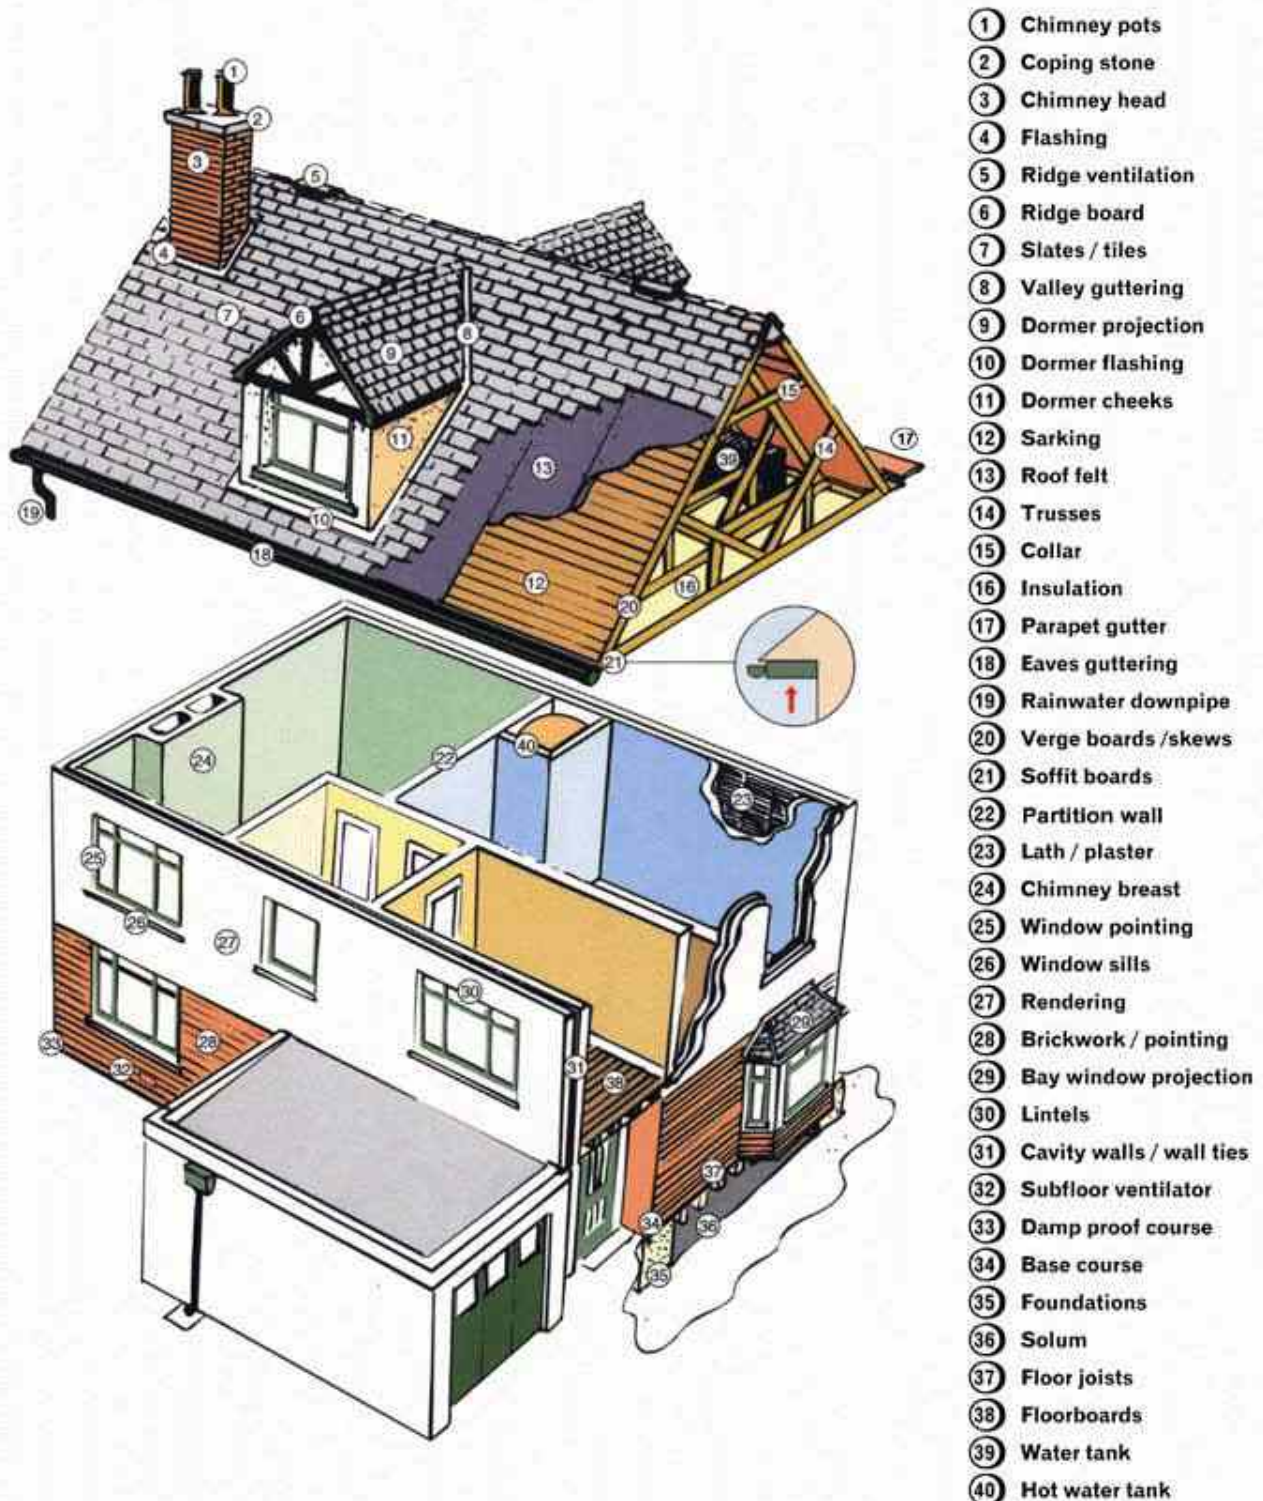
Sectional Diagram showing elements of a typical house

Reference may be made in this report to some or all of the above component parts of the property. This diagram may assist you in locating and understanding these items.
